RE: Corrective Action Management Unit (CAMU) Construction Inspection on July 26, 2001.

FIELD INVESTIGATION REPORT

SITE: ASARCO East Helena

PURPOSE: Corrective Action Inspection (CAO). The purpose of the CAO was to observe the construction of a Corrective Action Management Unit (CAMU).

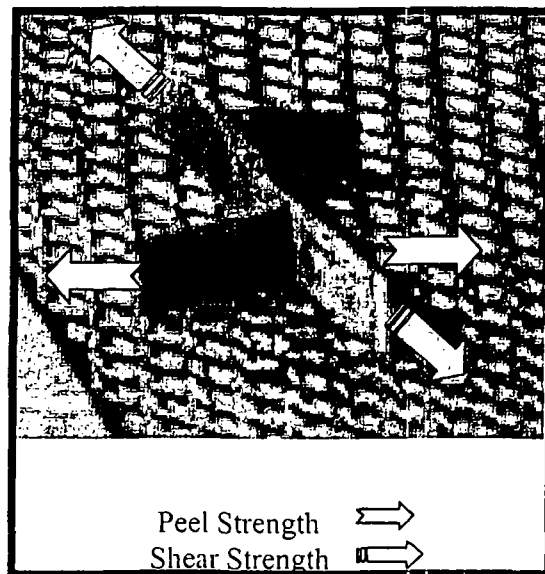
Figure 1: Coupon Tensiometer Pull Directions.

The inspection team observed the tensiometer testing of a coupon cut from a test seam. The seam consists of two 1-inch strips of welded material with a small air-filled conduit between the two strips. Photo 6 shows a worker who has just cut several coupons from a seam. The tensiometer measures the shear and peel strength of the seam. The arrows in Figure 1 below show the direction the coupons are pulled to measure shear strength and peel strength.

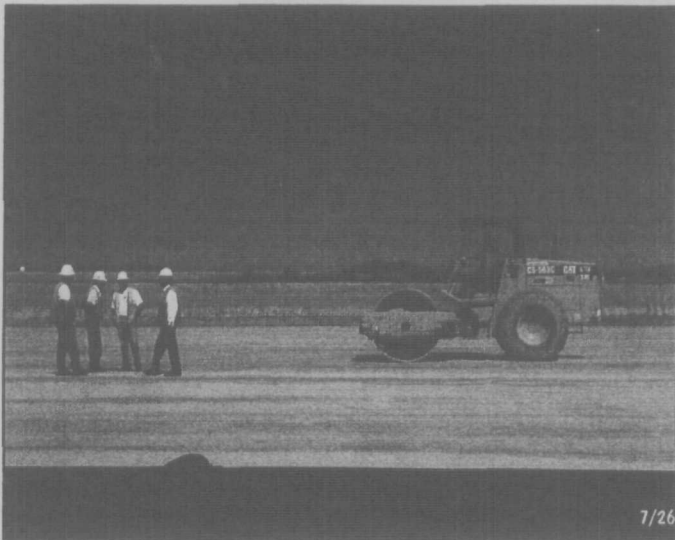
RESULTS OF INSPECTIONS: On July 25, the inspection team parked southwest of the county road at the CAMU's construction site entrance. Rod Kirschman from ASARCO and Kurt Wieringa, Envirocon's construction supervisor, met us at the site. Approximately one half (southeastern half) of the CAMU's compacted clay liner was complete. Clay liner construction was continuing on the northwestern half, with lifts being laid from the southwest edge to the northeast edge. Photo 1 shows the roller compactor finishing a final clay lift. A water truck and a farm implement disking the clay

PROJECT/CASE NO: ASARCO E. Helena CAMU
 SUBJECT: Roller compactor
 LOCATION: Bottom of CAMU
 CITY: E. Helena COUNTY: Lewis & Clark
 DATE: 07/26/01 TIME: AM
 WEATHER: (SUN)(HAZE)(CLOUDY)(RAIN)(SNOW)
 PHOTOGRAPHER (initials) Adel Johnson
 WITNESS: Susan Zazzali, EPA
 CAMERA: Kodak DC290 Zoom Digital Camera
 PHOTO FILE LOCATION:
 F:/CB5489/WP/Asarco/CA/pictures/P0000175pg
 PHOTO# 1

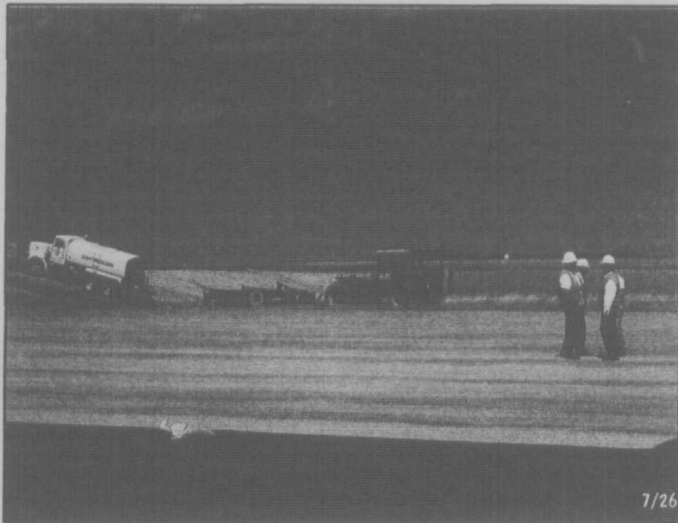
material are shown in Photo 2.

PROJECT/CASE NO: ASARCO E. Helena CAMU
 SUBJECT: Water truck and tractor
 LOCATION: Bottom of the CAMU
 CITY: E. Helena COUNTY: Lewis & Clark
 DATE: 07/26/01 TIME: AM
 WEATHER: (SUN)(HAZE)(CLOUDY)(RAIN)(SNOW)
 PHOTOGRAPHER (initials) Adel Johnson
 WITNESS: Susan Zazzali, EPA
 CAMERA: Kodak DC290 Zoom Digital Camera
 PHOTO FILE LOCATION:
 F:/CB5489/WP/Asarco/CA/pictures/P0000176pg
 PHOTO# 2

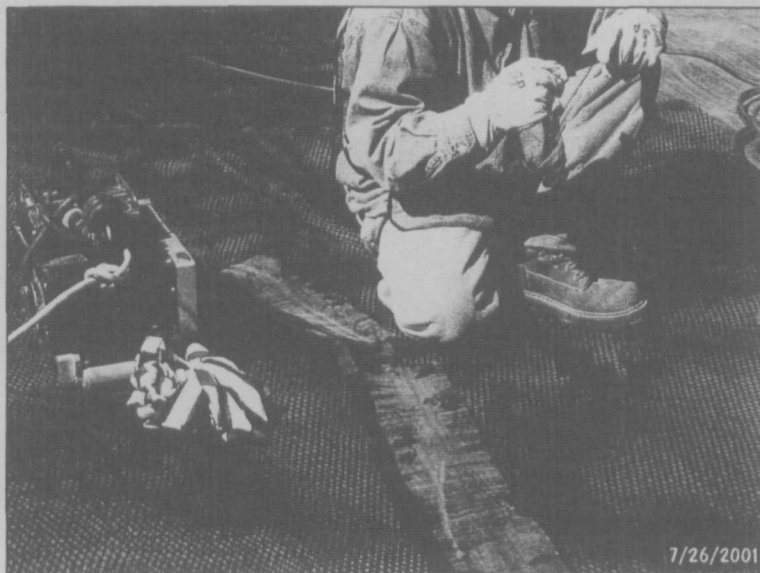
PROJECT/CASE NO: ASARCO E. Helena CAMU
 SUBJECT: Seam sealer, test seam, and coupons
 LOCATION: Bottom of CAMU
 CITY: E. Helena COUNTY: Lewis & Clark
 DATE: 07/26/01 TIME: AM
 WEATHER: (SUN)(HAZE)(CLOUDY)(RAIN)(SNOW)
 PHOTOGRAPHER (initials) Adel Johnson
 WITNESS: Susan Zazzali, EPA
 CAMERA: Kodak DC290 Zoom Digital Camera
 PHOTO FILE LOCATION:
 F:/CB5489/WP/Asarco/CA/pictures/P0000189pg
 PHOTO# 6

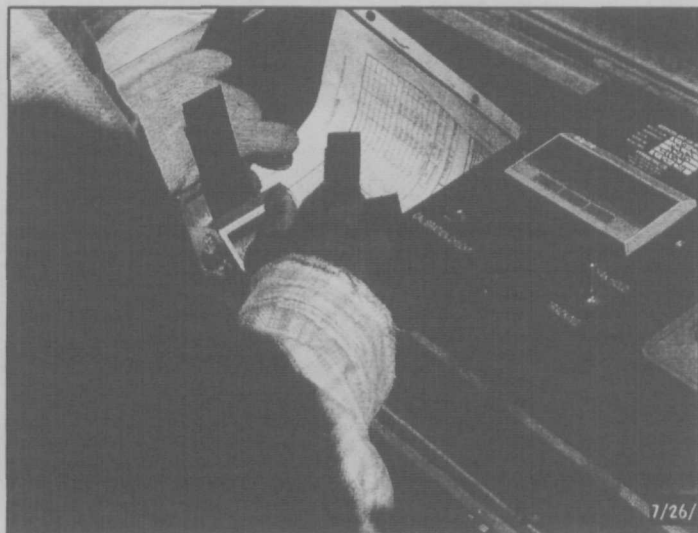
Photos 7 and 8 show the worker testing the coupons in a Columbine International LTD Accuralite tensiometer (SN NAL-3096). The sticker above the tensiometer's digital readout shows the machine was serviced and calibrated on 01/06/01.

PROJECT/CASE NO: ASARCO E. Helena CAMU
 SUBJECT: Tensiometer
 LOCATION: Bottom of the CAMU
 CITY: E. Helena COUNTY: Lewis & Clark
 DATE: 07/26/01 TIME: AM
 WEATHER: (SUN)(HAZE)(CLOUDY)(RAIN)(SNOW)
 PHOTOGRAPHER (initials) Adel Johnson
 WITNESS: Susan Zazzali, EPA
 CAMERA: Kodak DC290 Zoom Digital Camera
 PHOTO FILE LOCATION:
 F:/CB5489/WP/Asarco/CA/pictures/P0000179pg
 PHOTO# 7

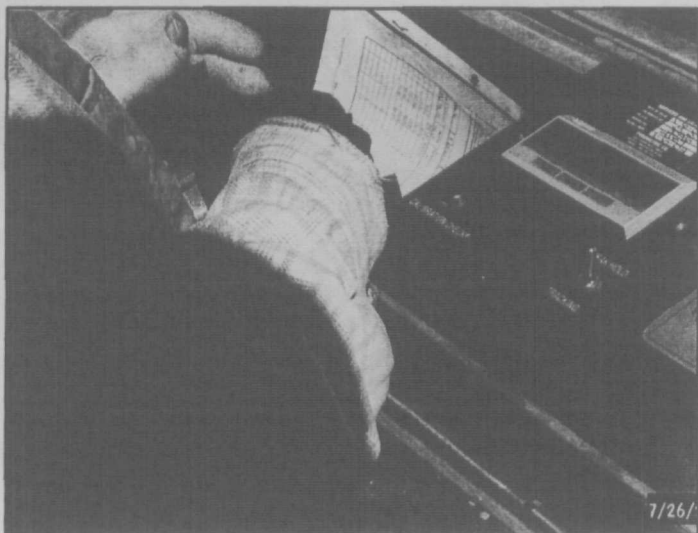
PROJECT/CASE NO: ASARCO E. Helena CAMU
 SUBJECT: Tensiometer
 LOCATION: Bottom of the CAMU
 CITY: E. Helena COUNTY: Lewis & Clark
 DATE: 07/26/01 TIME: AM
 WEATHER: (SUN)(HAZE)(CLOUDY)(RAIN)(SNOW)
 PHOTOGRAPHER (initials) Adel Johnson
 WITNESS: Susan Zazzali, EPA
 CAMERA: Kodak DC290 Zoom Digital Camera
 PHOTO FILE LOCATION:
 F:/CB5489/WP/Asarco/CA/pictures/P0000178pg
 PHOTO# 8

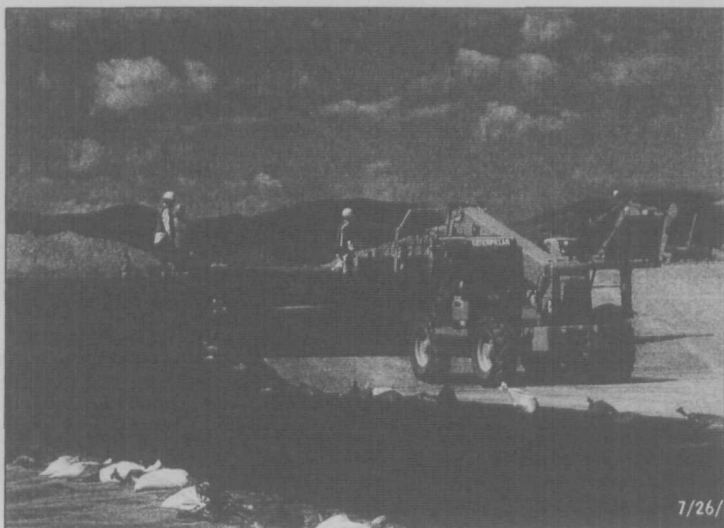
We observed the placement and sealing of the liner material. First, a roll of liner material is attached to a forklift. The end of the liner material is held in place by the workers as the forklift moves backward, unrolling the HDPE liner onto the clay liner. See Photos 9 and 10. The workers feed the overlapped panels into a seam sealer that is powered by a portable generator. As the seam sealer propels itself along the seam, the operator wipes the liner material in front of the machine with a clean cloth. See Photo 11. After each panel is sealed, it is labeled with chalk. See Photo 12. Sandbags are strategically placed on the panels to protect them from the wind as shown in Photo 13. Geonet material is then placed over the liner. No geonet material was in place on July 25. Photos 6, 12, and 13 show the geonet material in place on July 26.

PROJECT/CASE NO: ASARCO E. Helena CAMU
 SUBJECT: Unrolling the liner
 LOCATION: CAMU's southwest edge
 CITY: E. Helena COUNTY: Lewis & Clark
 DATE: 07/26/01 TIME: AM
 WEATHER: (SUN)(HAZE)(CLOUDY)(RAIN)(SNOW)
 PHOTOGRAPHER (initials) Adel Johnson AJ
 WITNESS: Susan Zazzali, EPA
 CAMERA: Kodak DC290 Zoom Digital Camera
 PHOTO FILE LOCATION:
 F:/CB5489/WP/Asarco/CA/pictures/P0000173pg
 PHOTO# 9

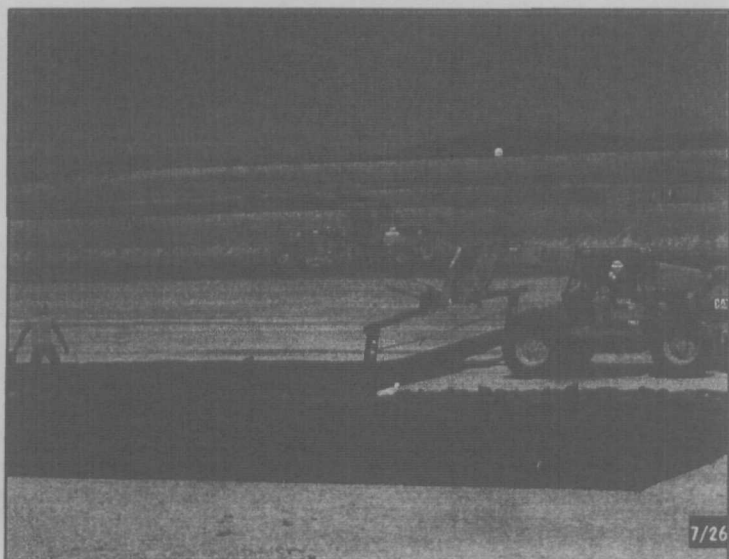
PROJECT/CASE NO: ASARCO E. Helena CAMU
 SUBJECT: Unrolling the liner
 LOCATION: Bottom of the CAMU
 CITY: E. Helena COUNTY: Lewis & Clark
 DATE: 07/26/01 TIME: AM
 WEATHER: (SUN)(HAZE)(CLOUDY)(RAIN)(SNOW)
 PHOTOGRAPHER (initials) Adel Johnson AJ
 WITNESS: Susan Zazzali, EPA
 CAMERA: Kodak DC290 Zoom Digital Camera
 PHOTO FILE LOCATION:
 F:/CB5489/WP/Asarco/CA/pictures/P0000173pg
 PHOTO# 10

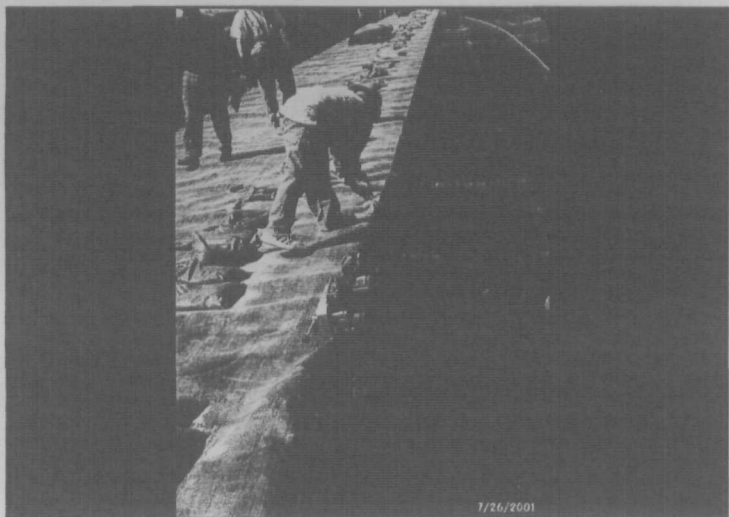
PROJECT/CASE NO: ASARCO E. Helena CAMU
 SUBJECT: Seam sealing the HDPE liner
 LOCATION: Bottom of the CAMU
 CITY: E. Helena COUNTY: Lewis & Clark
 DATE: 07/26/01 TIME: AM
 WEATHER: (SUN)(HAZE)(CLOUDY)(RAIN)(SNOW)
 PHOTOGRAPHER (initials) Adel Johnson AJ
 WITNESS: Susan Zazzali, EPA
 CAMERA: Kodak DC290 Zoom Digital Camera
 PHOTO FILE LOCATION:
 F:/CB5489/WP/Asarco/CA/pictures/P0000181pg
 PHOTO# 11

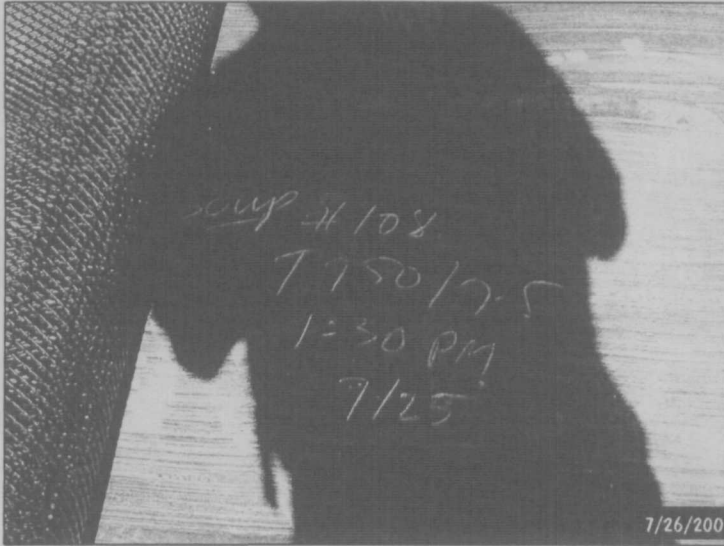
PROJECT/CASE NO: ASARCO E. Helena CAMU
 SUBJECT: HDPE liner marking
 LOCATION: Bottom of the CAMU
 CITY: E. Helena COUNTY: Lewis & Clark
 DATE: 07/26/01 TIME: AM
 WEATHER: (SUN)(HAZE)(CLOUDY)(RAIN)(SNOW)
 PHOTOGRAPHER (initials) Adel Johnson
 WITNESS: Susan Zazzali, EPA
 CAMERA: Kodak DC290 Zoom Digital Camera
 PHOTO FILE LOCATION:
 F:/CB5489/WP/Asarco/CA/pictures/P0000170.jpg
 PHOTO# 12

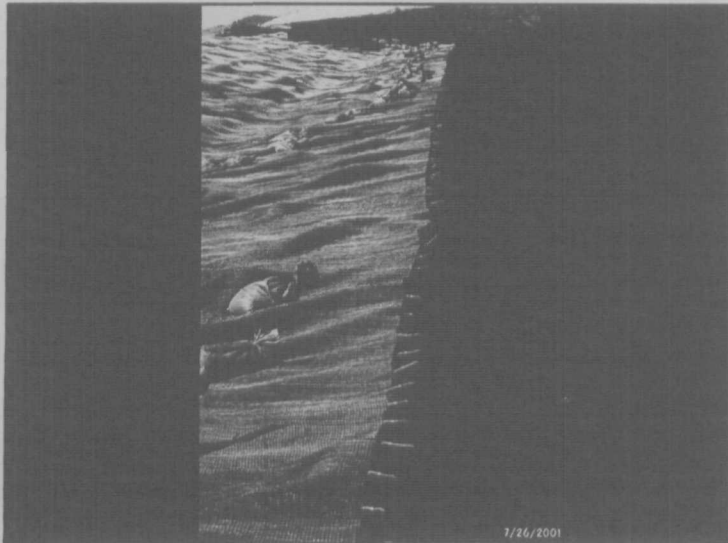
PROJECT/CASE NO: ASARCO E. Helena CAMU
 SUBJECT: Geonet
 LOCATION: Bottom of the CAMU
 CITY: E. Helena COUNTY: Lewis & Clark
 DATE: 07/26/01 TIME: AM
 WEATHER: (SUN)(HAZE)(CLOUDY)(RAIN)(SNOW)
 PHOTOGRAPHER (initials) Adel Johnson
 WITNESS: Susan Zazzali, EPA
 CAMERA: Kodak DC290 Zoom Digital Camera
 PHOTO FILE LOCATION:
 F:/CB5489/WP/Asarco/CA/pictures/P0000174.jpg
 PHOTO# 13

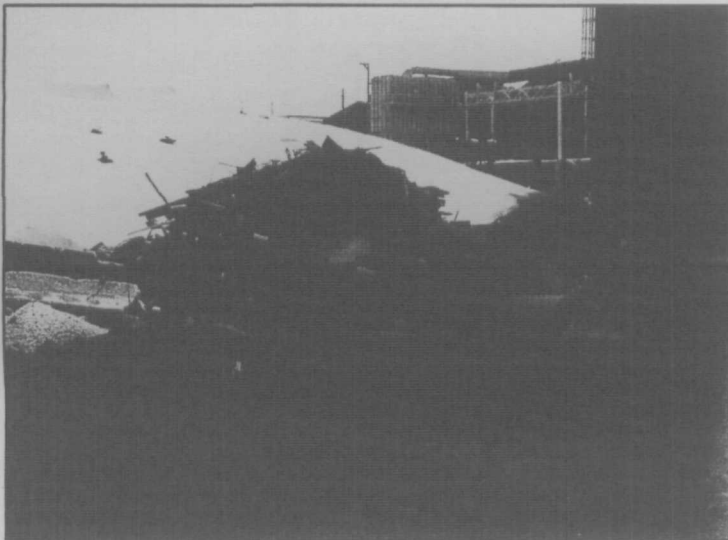
On July 26, the inspection team returned to the CAMU construction site to take photos. The inspection team also viewed the Shew Ridge stockpile with Darrel Shew, ASARCO. Photo 14 shows the waste material that was separated from stockpile. The waste material will be sized and/or compacted and placed in the CAMU. Photo 15 shows part of the stockpile.

PROJECT/CASE NO: ASARCO E. Helena CAMU
 SUBJECT: Sorted debris from Shew Ridge
 LOCATION: Lower Lake sediment pile in background
 CITY: E. Helena COUNTY: Lewis & Clark
 DATE: 07/26/01 TIME: AM
 WEATHER: (SUN)(HAZE)(CLOUDY)(RAIN)(SNOW)
 PHOTOGRAPHER (initials) Adel Johnson
 WITNESS: Susan Zazzali, EPA
 CAMERA: Kodak DC290 Zoom Digital Camera
 PHOTO FILE LOCATION:
 F:/CB5489/WP/Asarco/CA/pictures/P0000183.jpg
 PHOTO# 14

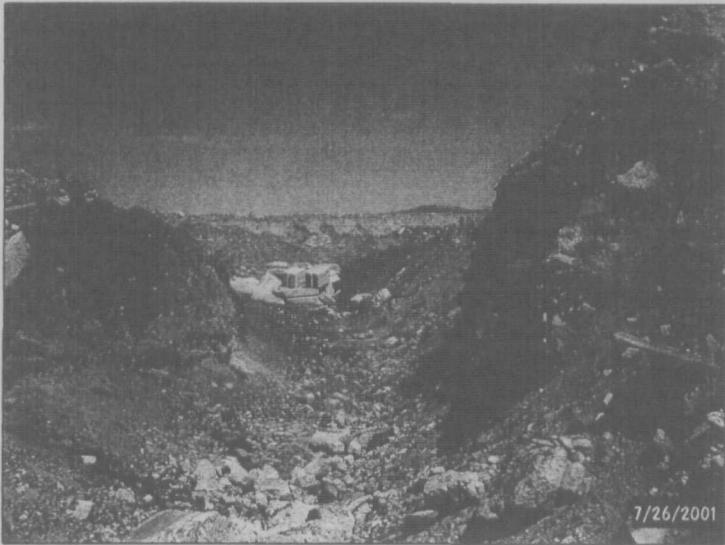
PHOTO# 15

SUBJECT: Shew Ridge
